RC
1042
.M38
1990a
c.2

Department
of Transportation
National Highway
Traffic Safety
Administration

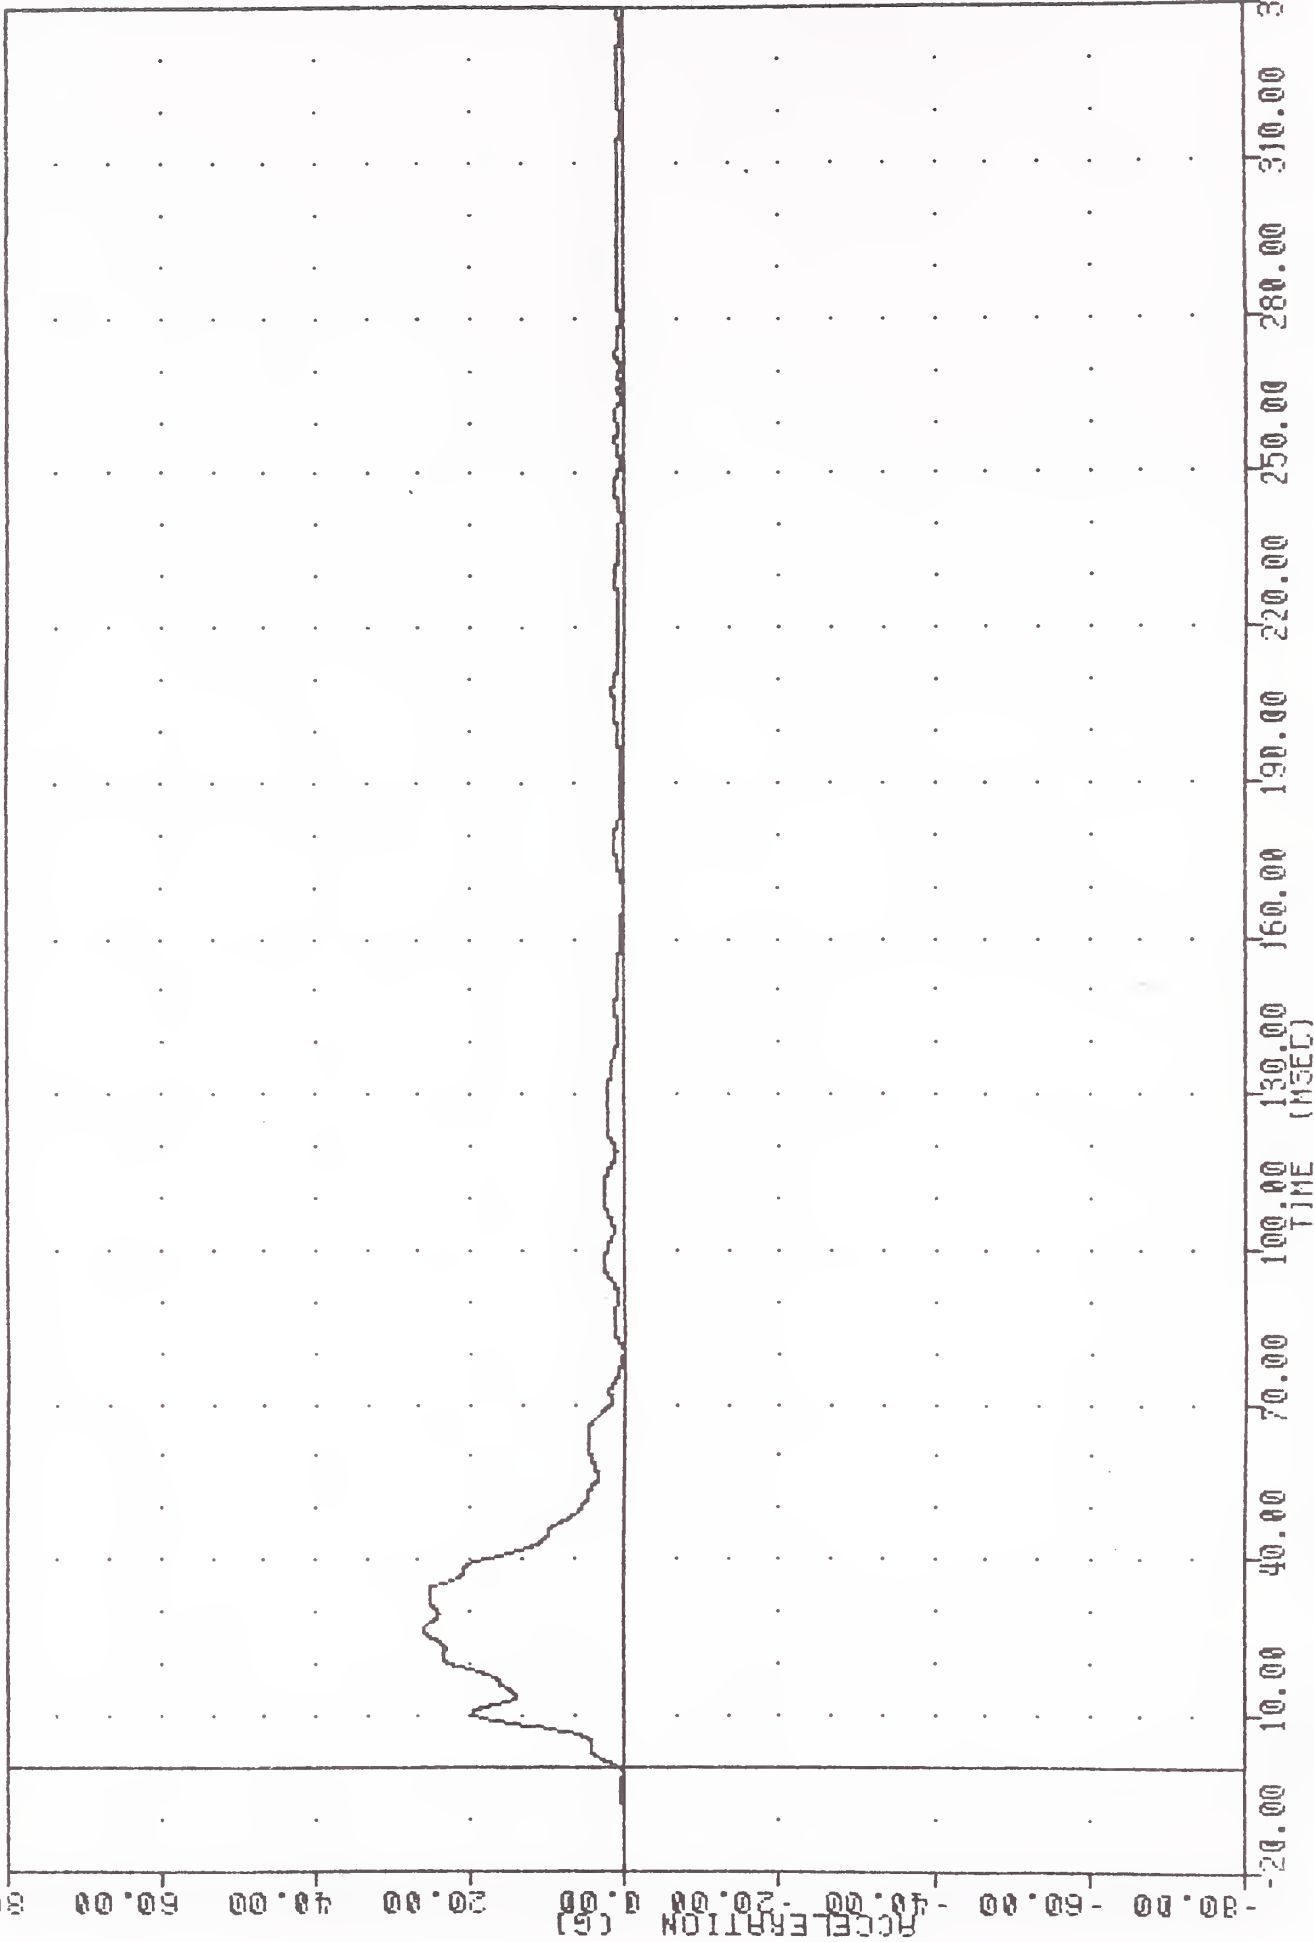
CONTOURED MOVING BARRIER INTO FORD ESCORT AT 39.8 MPH #4
LEFT FRONT SILL RESULTANT ACCELERATION

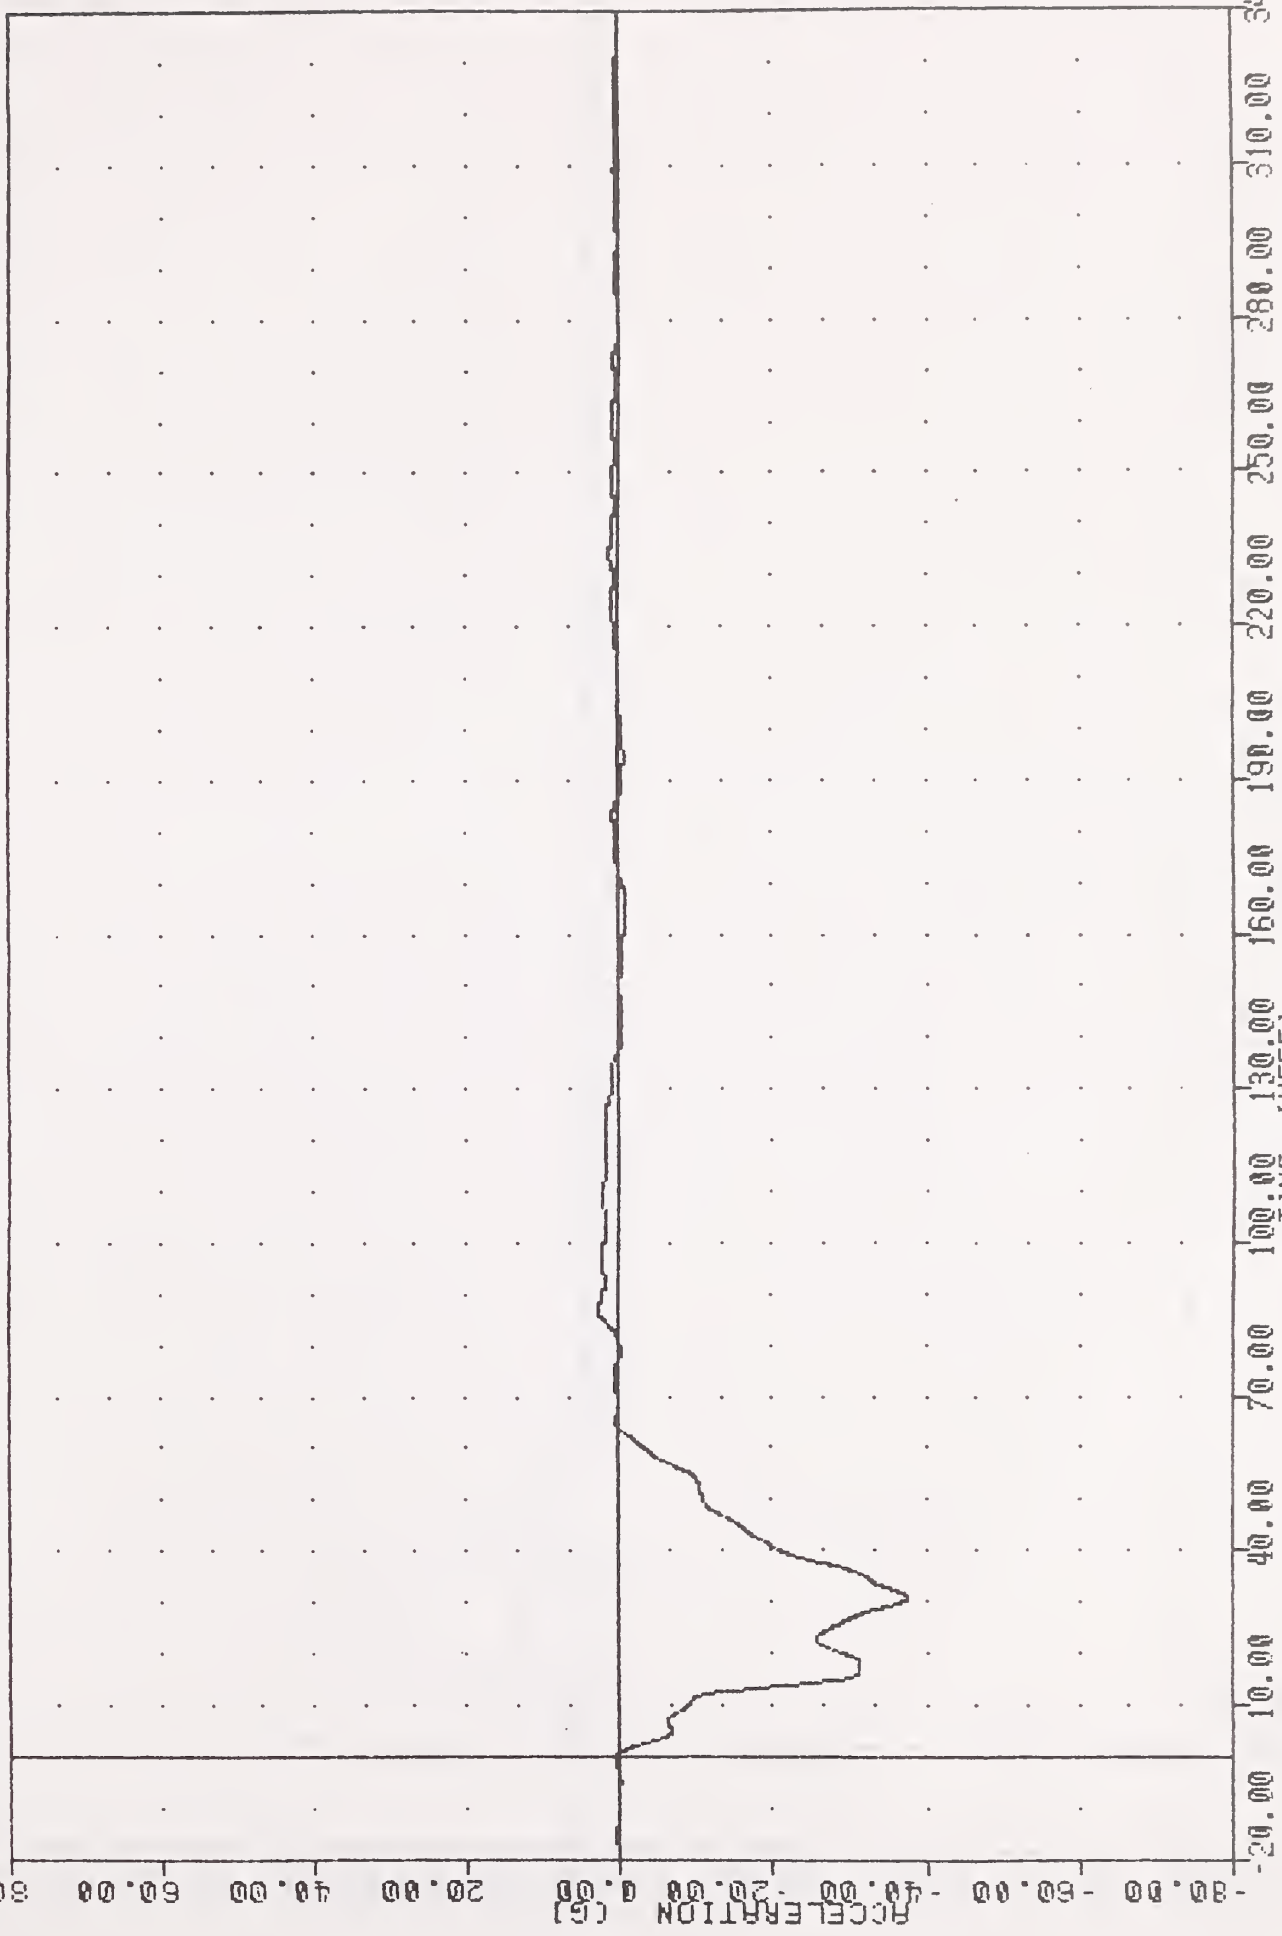
CONTOURED MOVING BARRIER INTO FORD ESCORT AT 39.8 MPH ±4
 RIGHT FRONT SILL X-AXIS ACCELERATION

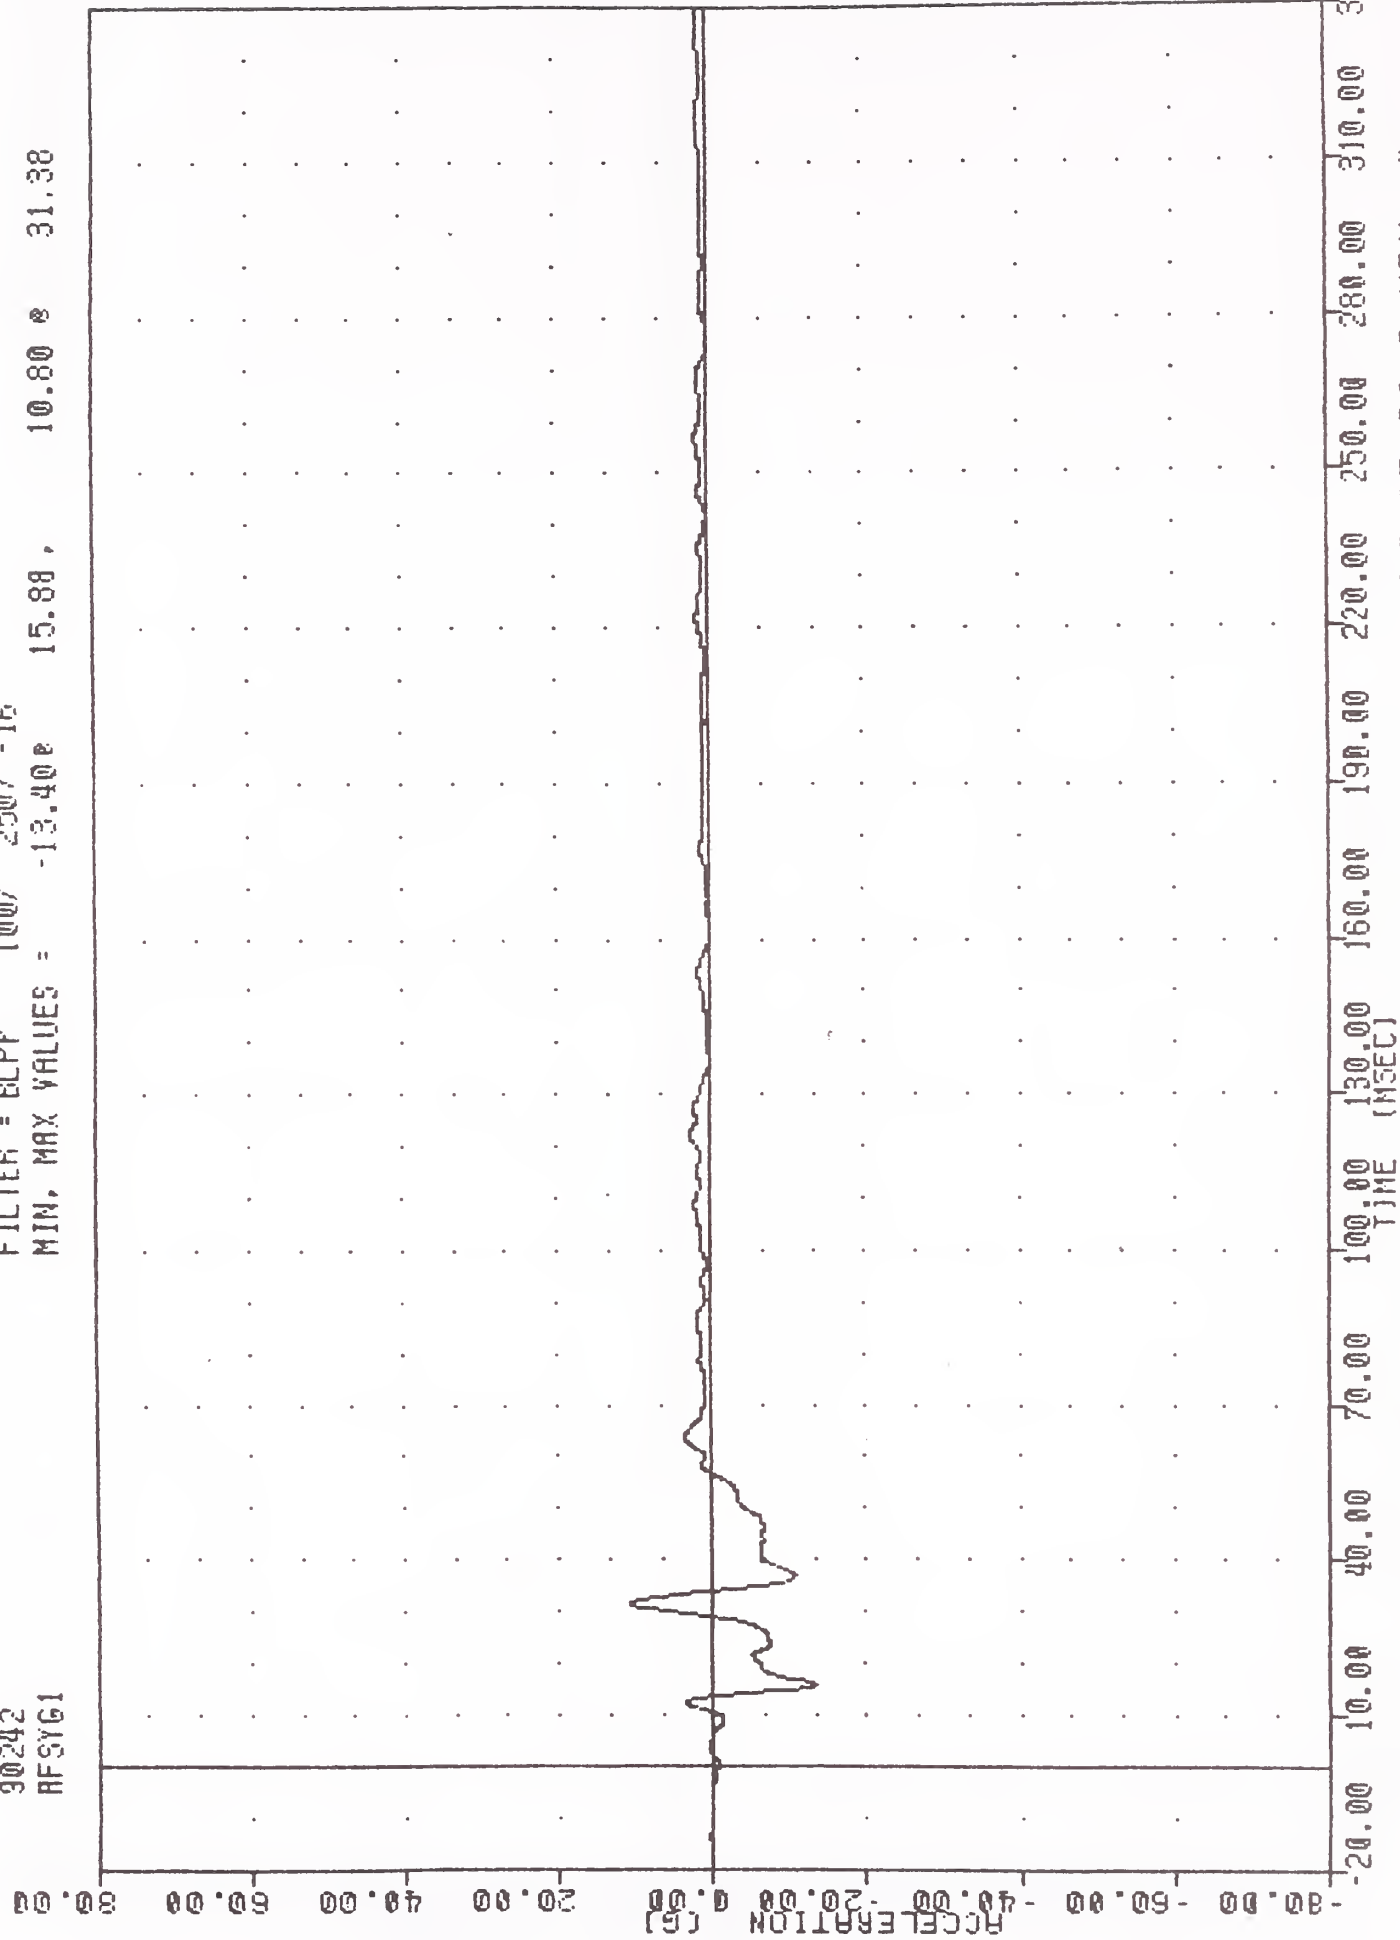
CONTOURED MOVING BARRIER INTO FORD ESCORT AT 39.8 MPH #4
 RIGHT FRONT SILL Y-AXIS ACCELERATION

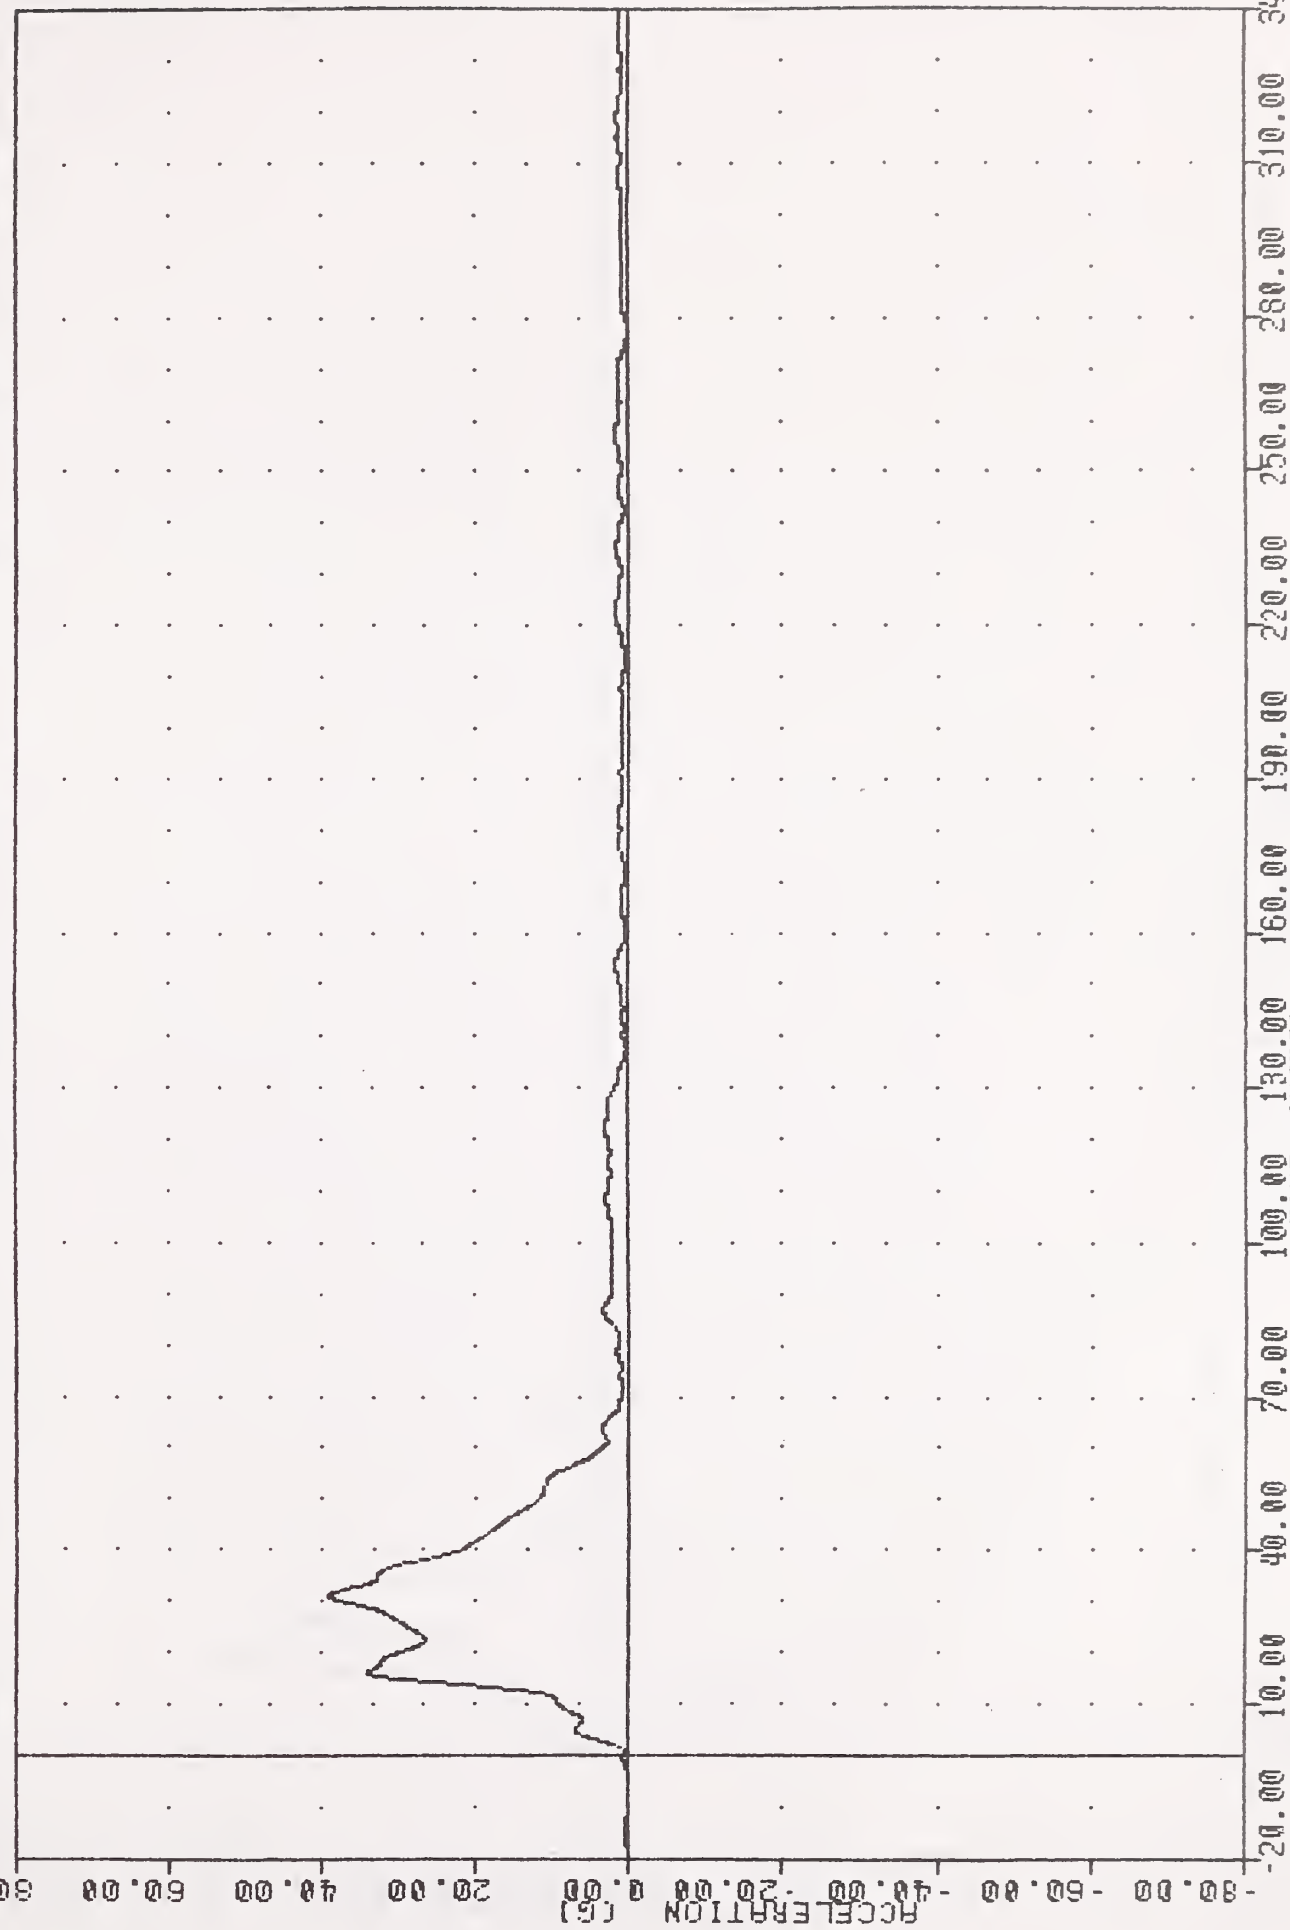
CONTOURED MOVING BARRIER INTO FORD ESCORT AT 39.8 MPH #4
RIGHT FRONT SILL RESULTANT ACCELERATION

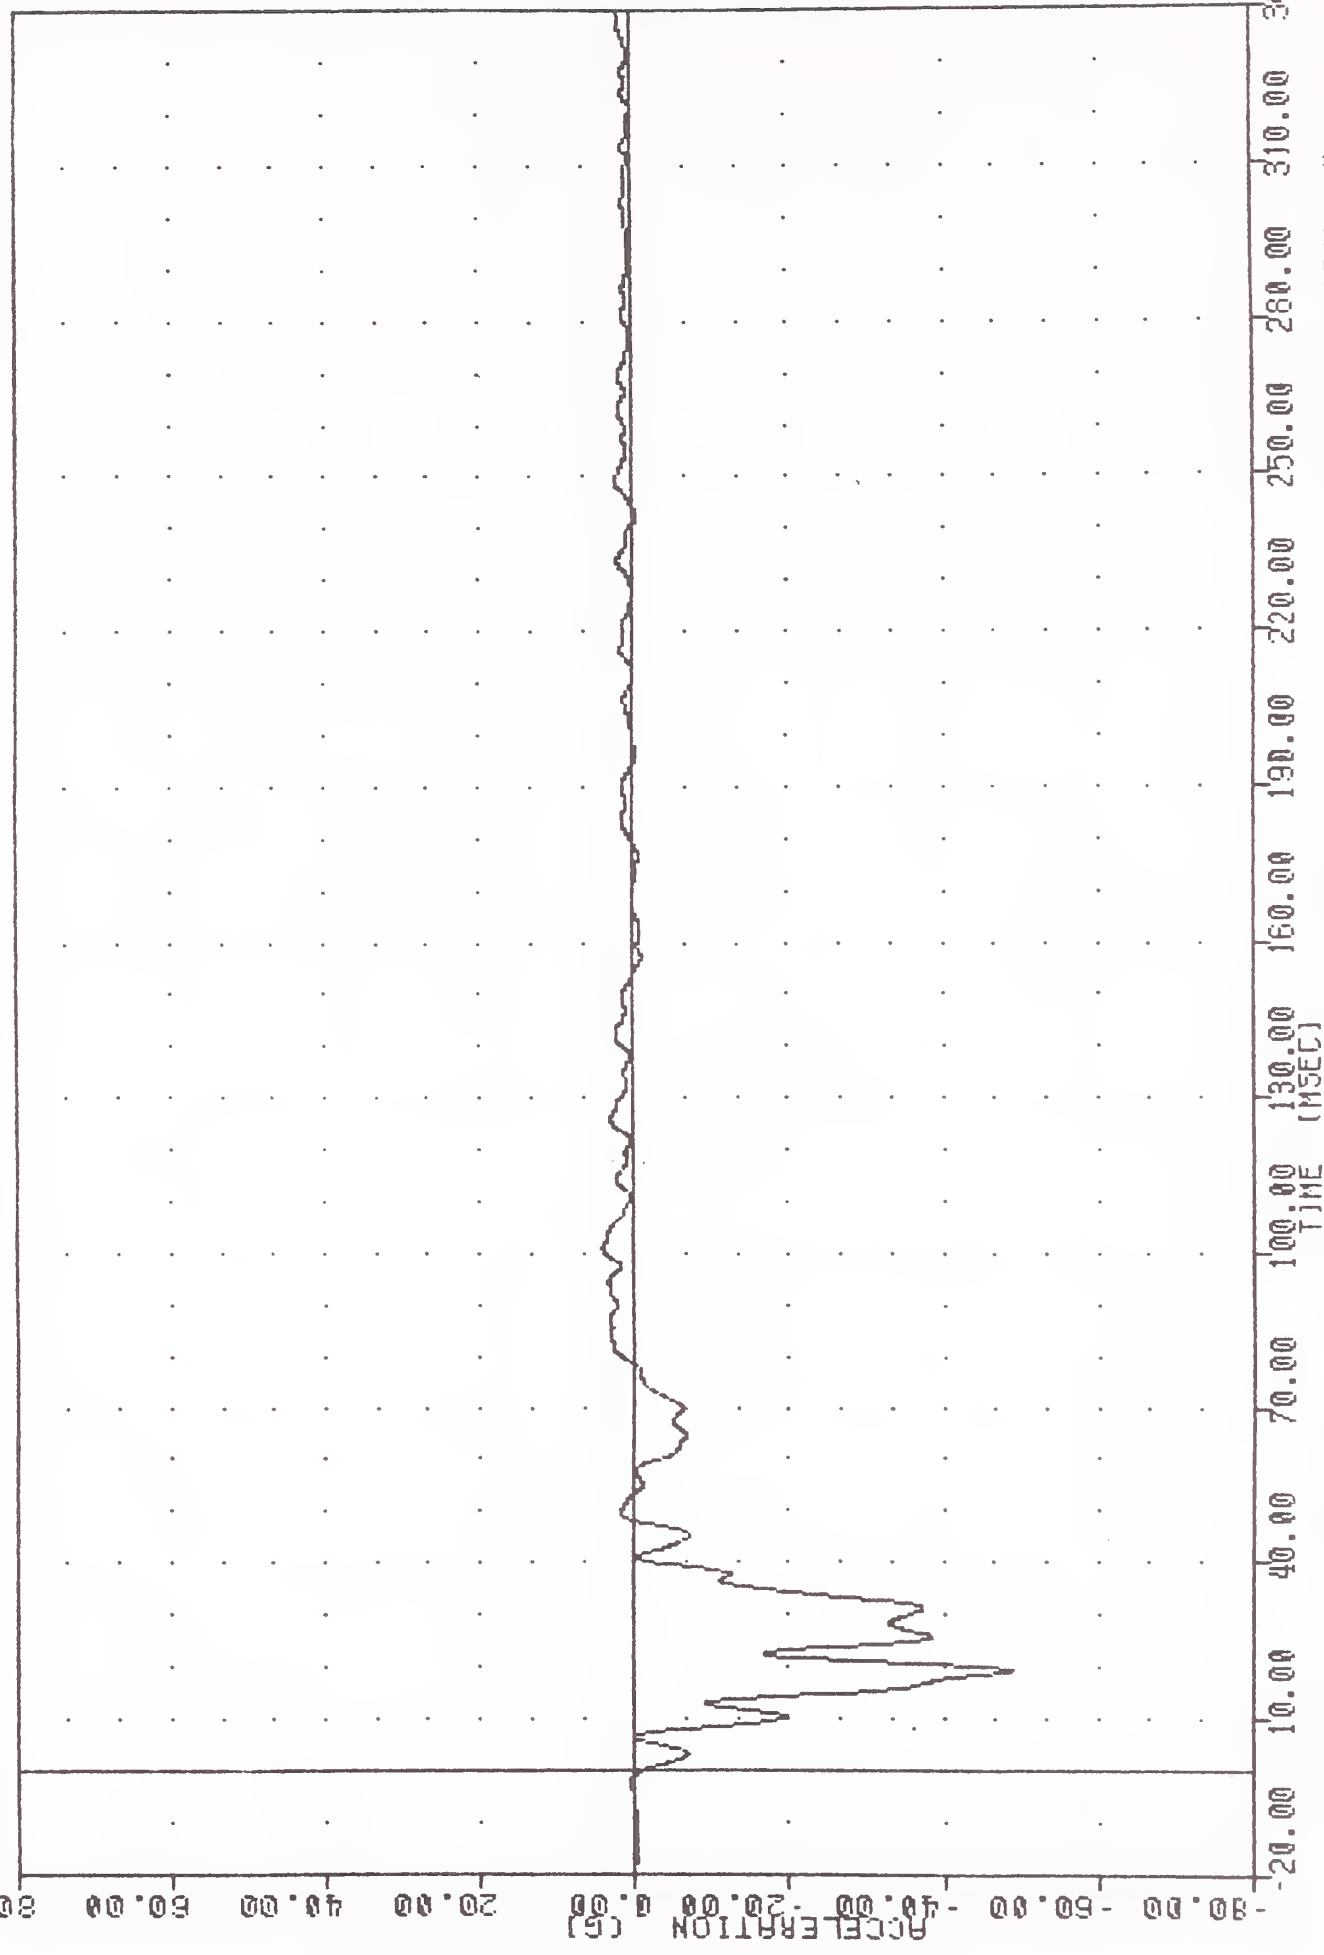
CONTOURED MOVING BARRIER INTO FORD ESCORT AT 39.8 MPH #4
VEHICLE CG X-AXIS ACCELERATION (IMPACT DIRECTION)

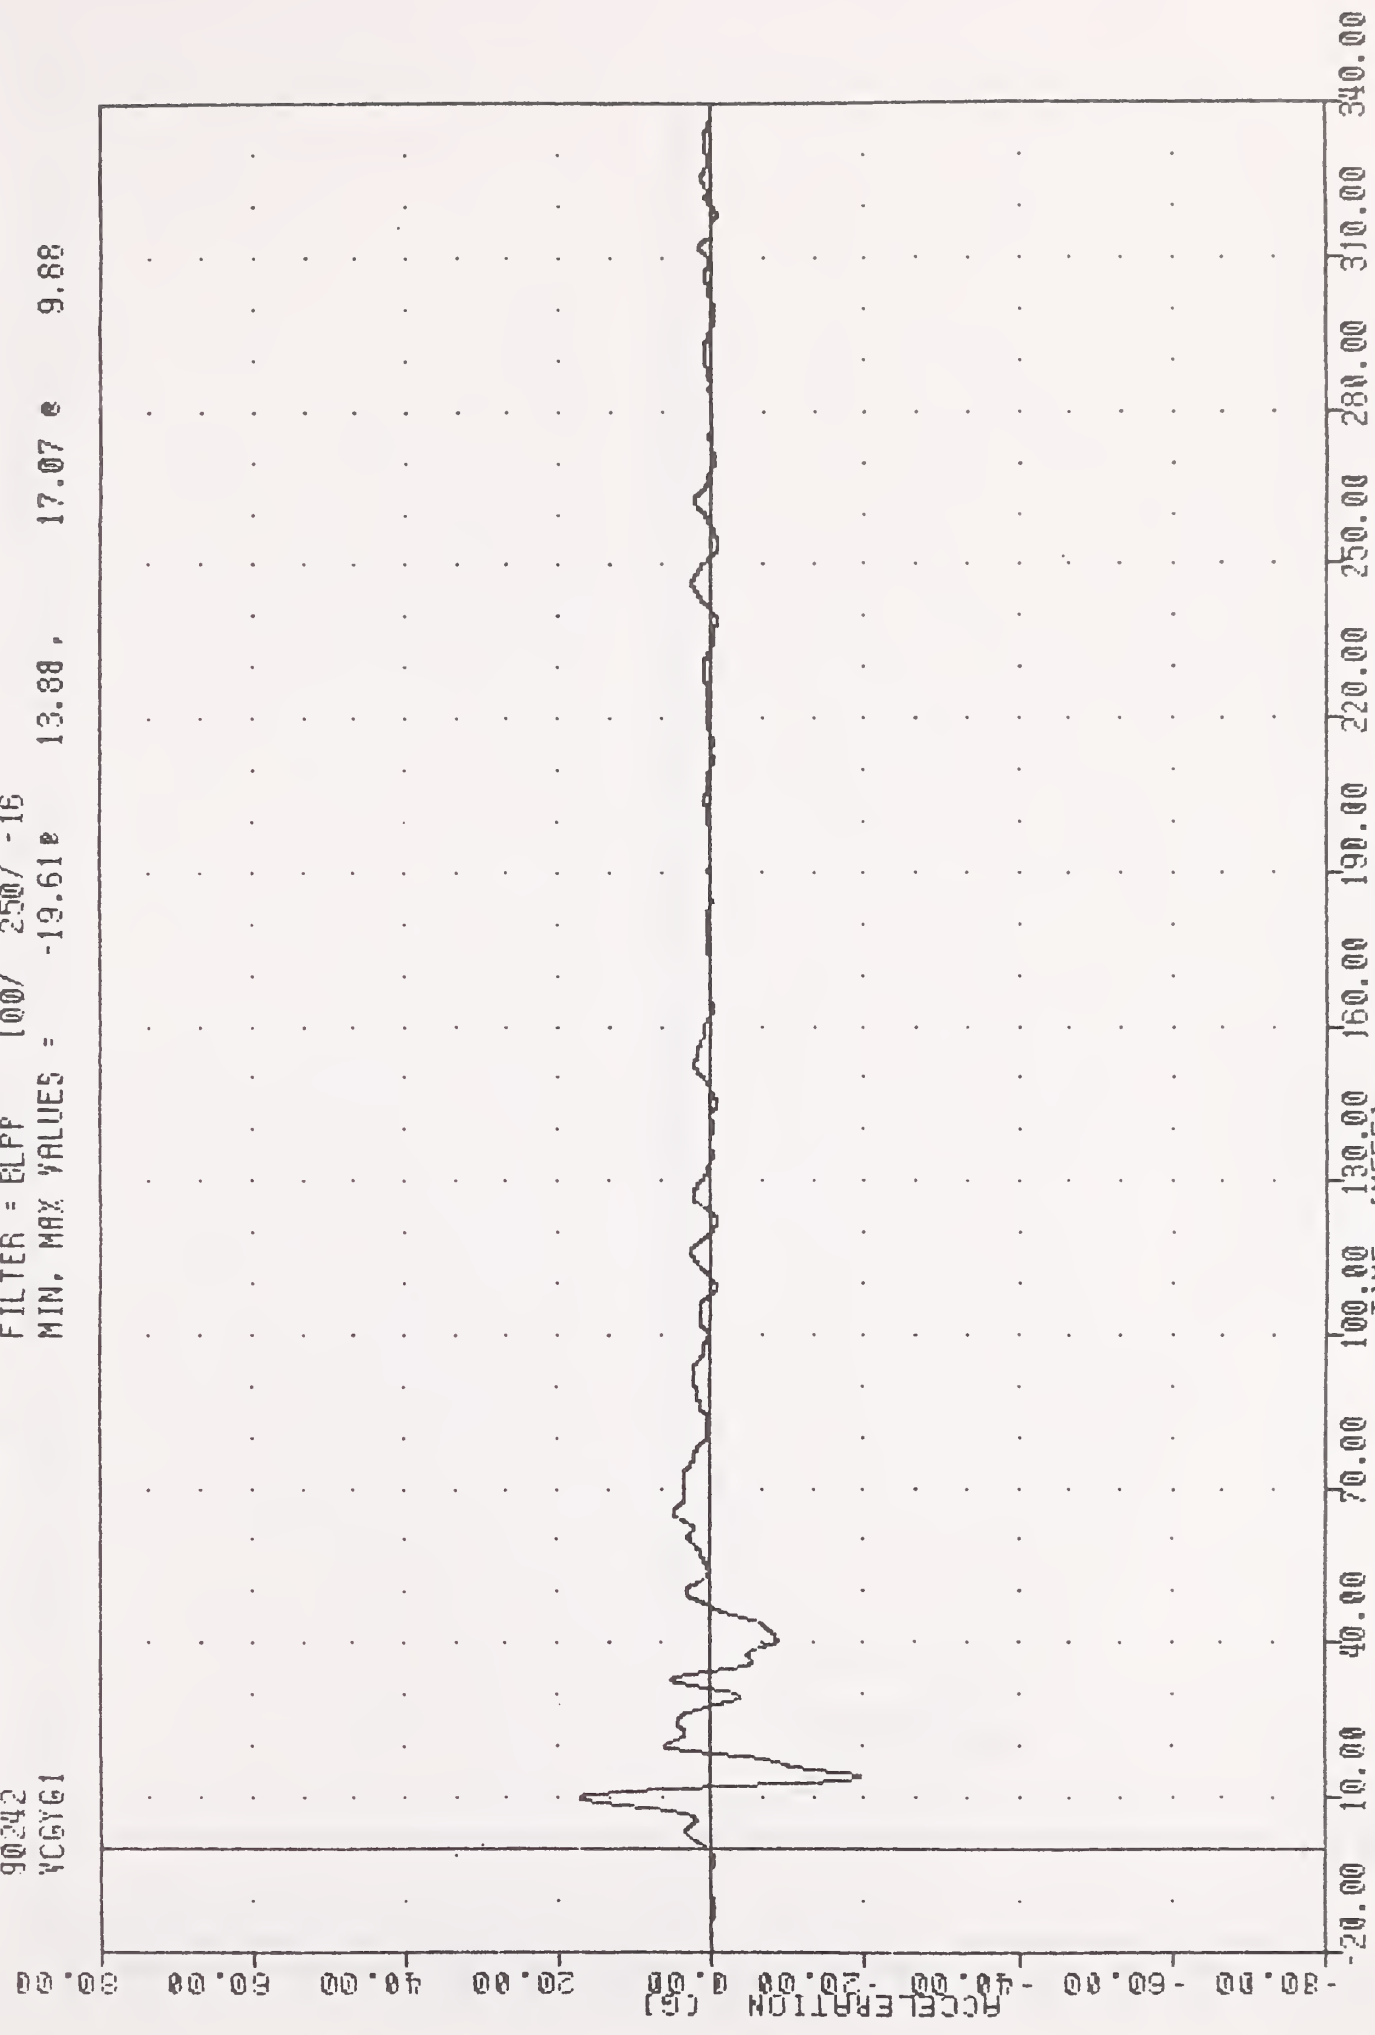
CONTOURED MOVING BARRIER INTO FORD ESCORT AT 39.8 MPH #4
 VEHICLE CG Y-AXIS ACCELERATION (PERPENDICULAR TO IMPACT DIRECTION)

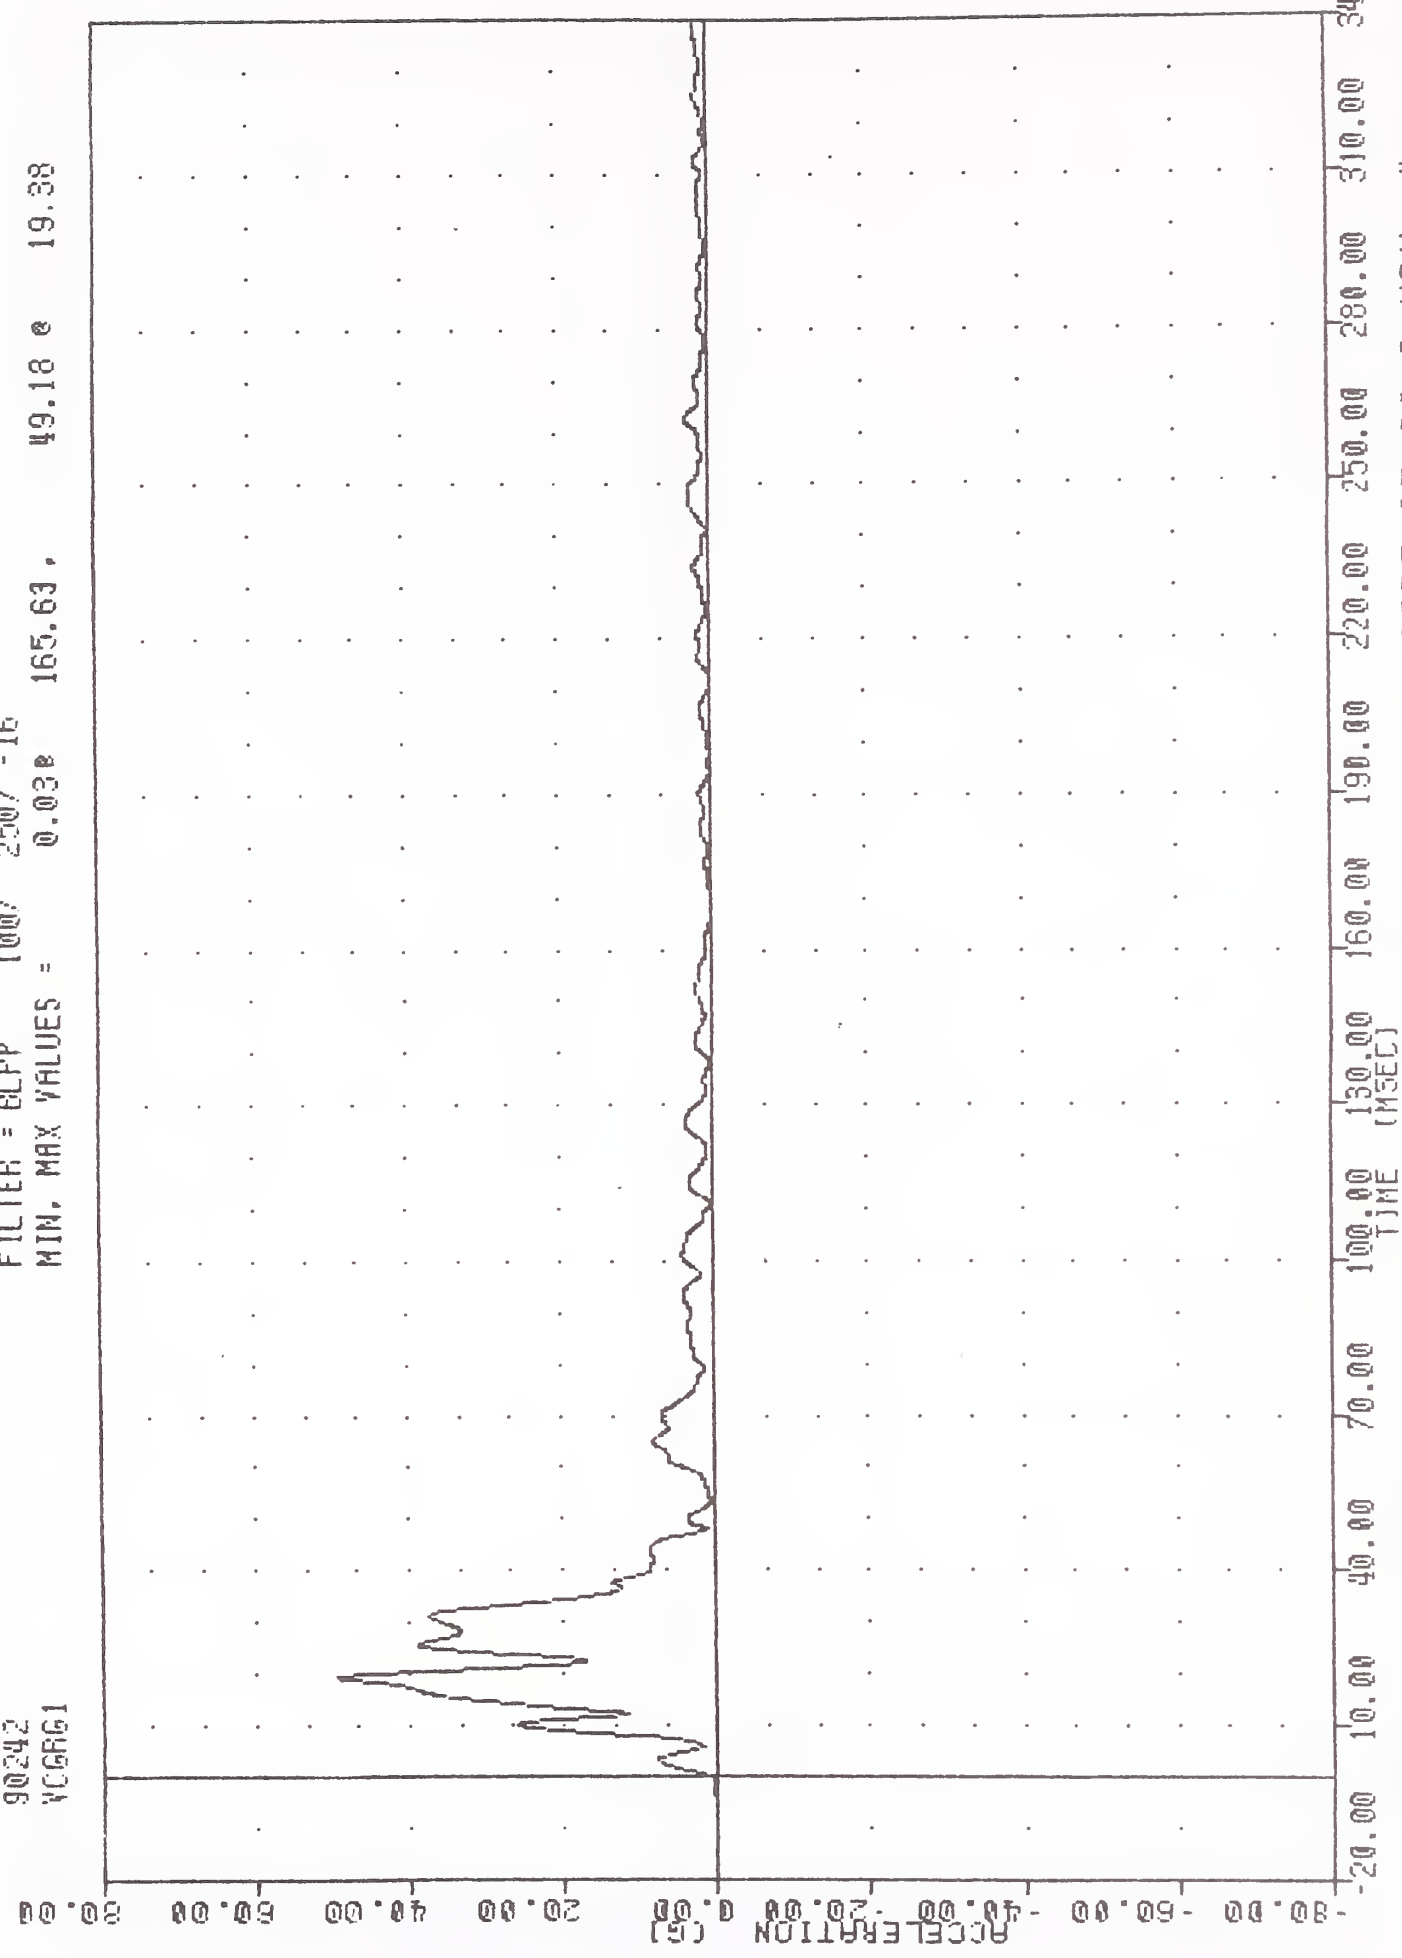
CONTOURED MOVING BARRIER INTO FORD ESCORT AT 39.8 MPH #4
 VEHICLE C6 RESULTANT ACCELERATION

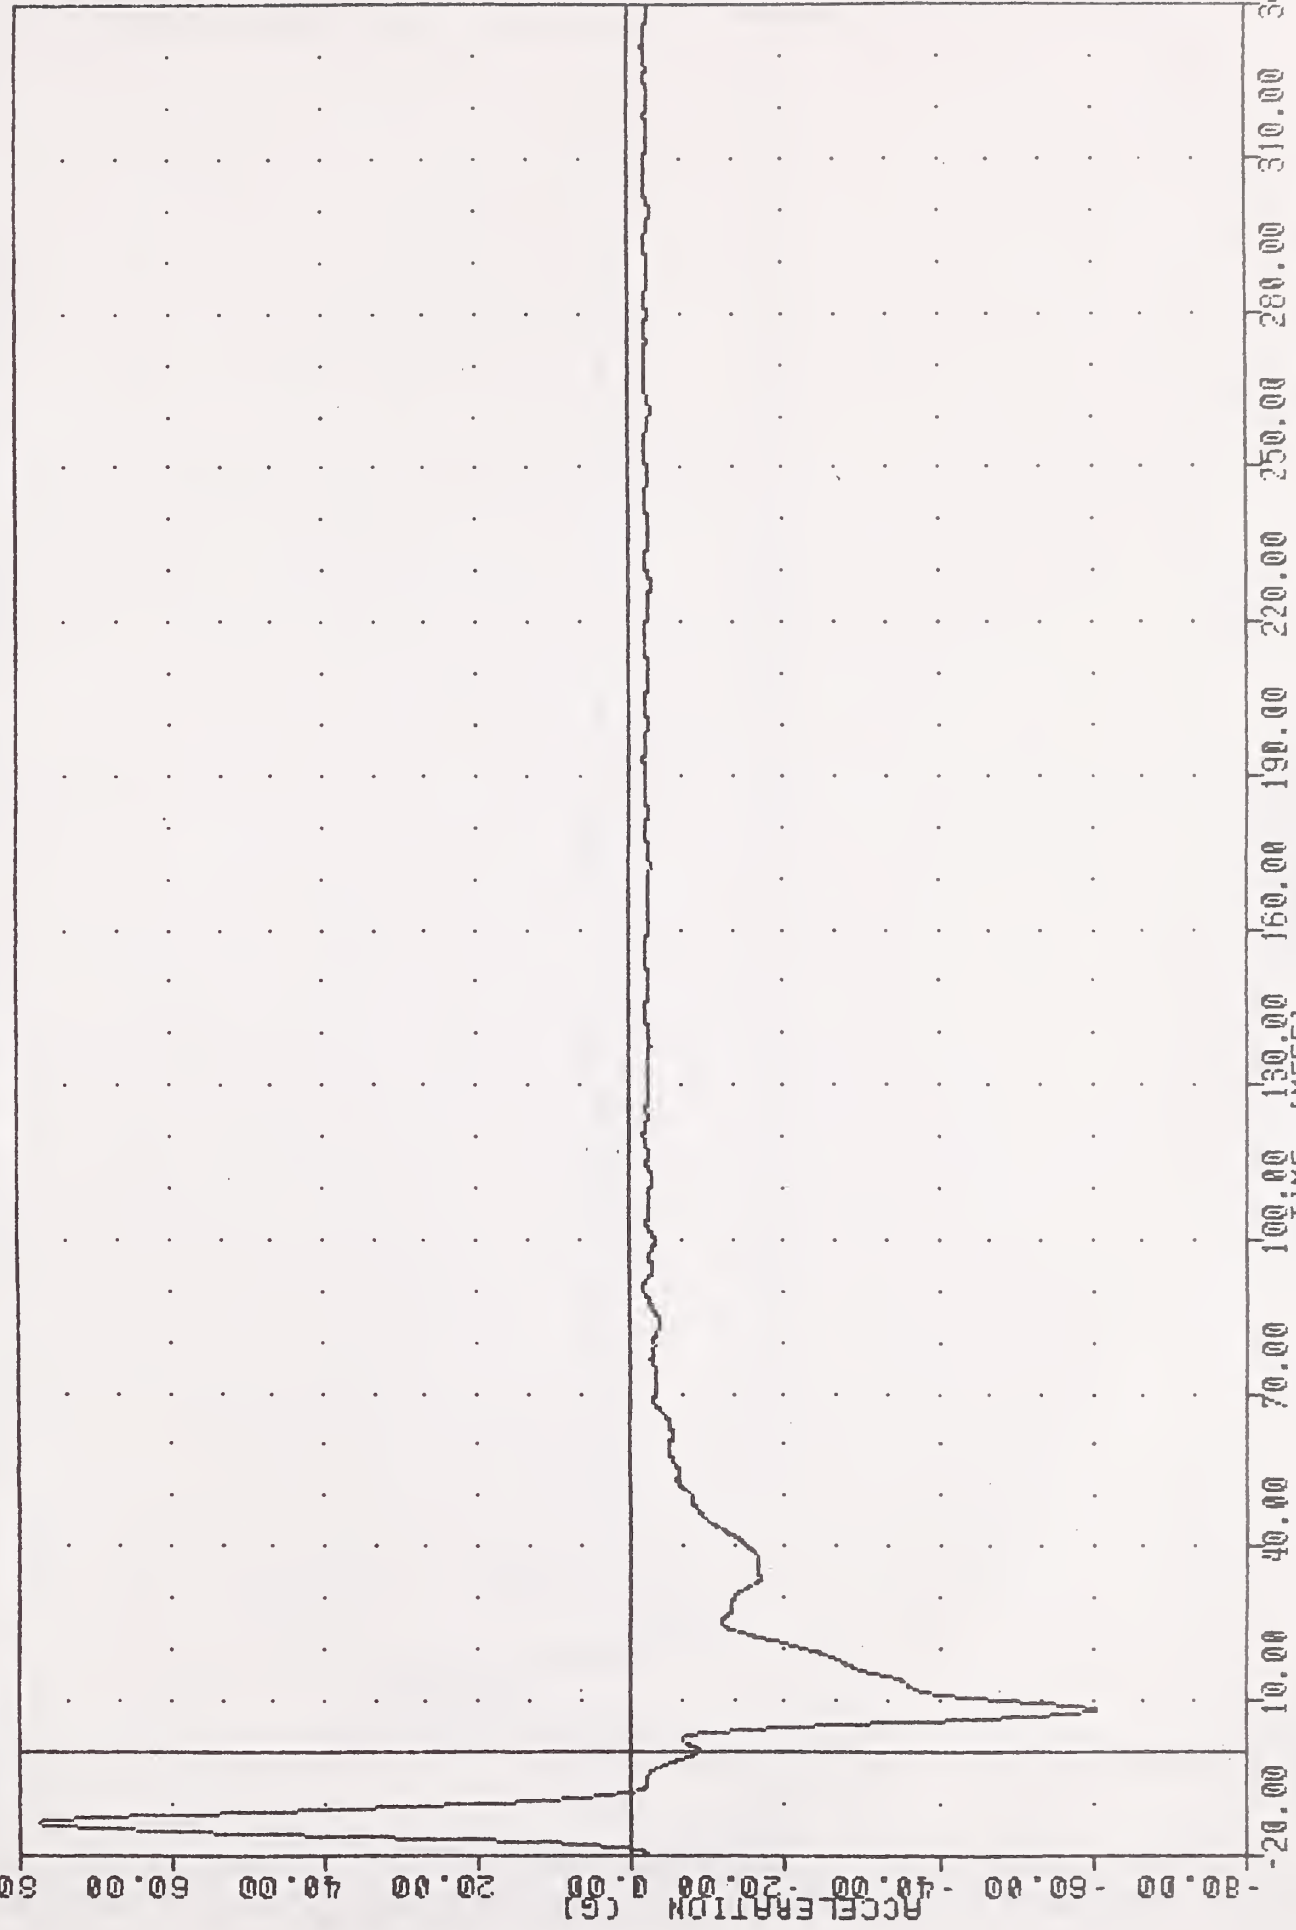
CONTOURED MOVING BARRIER INTO FORD ESCORT AT 39.8 MPH #4
 MOVING BARRIER CENTER OF GRAVITY X-AXIS ACCELERATION
